SUMMARY Pro-Elements Home Inspection 1234 Main St. Homestead FI 33030

Buyer Name 04/01/2021 9:00AM

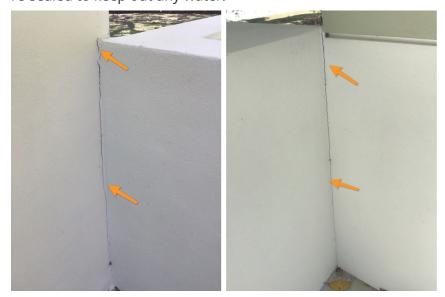
2.7.2 Stucco Walls

SEAL STUCCO BAND

The decorative stucco band are not properly sealed. There are openings/gaps where water will enter the and get behind the stucco causing the stucco to deteriorate. It is recommended to have the stucco bands re-sealed to keep out any water.

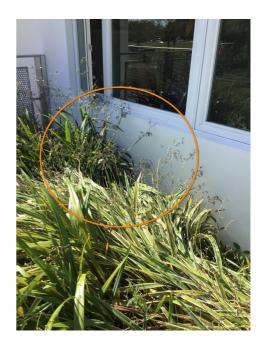
2.8.1 Vegetation and Grading

VEGETATION

Vegetation such as trees, shrubs and/or vines was in contact with or close to the building exterior. Vegetation can serve as a pathway for wood-destroying insects and can retain moisture against the exterior after it rains. This is a conducive condition for wood-destroying organisms. Recommend pruning, moving or removing vegetation as necessary to maintain at least 6 inches of space between it and the building exterior. A 1-foot clearance is better.

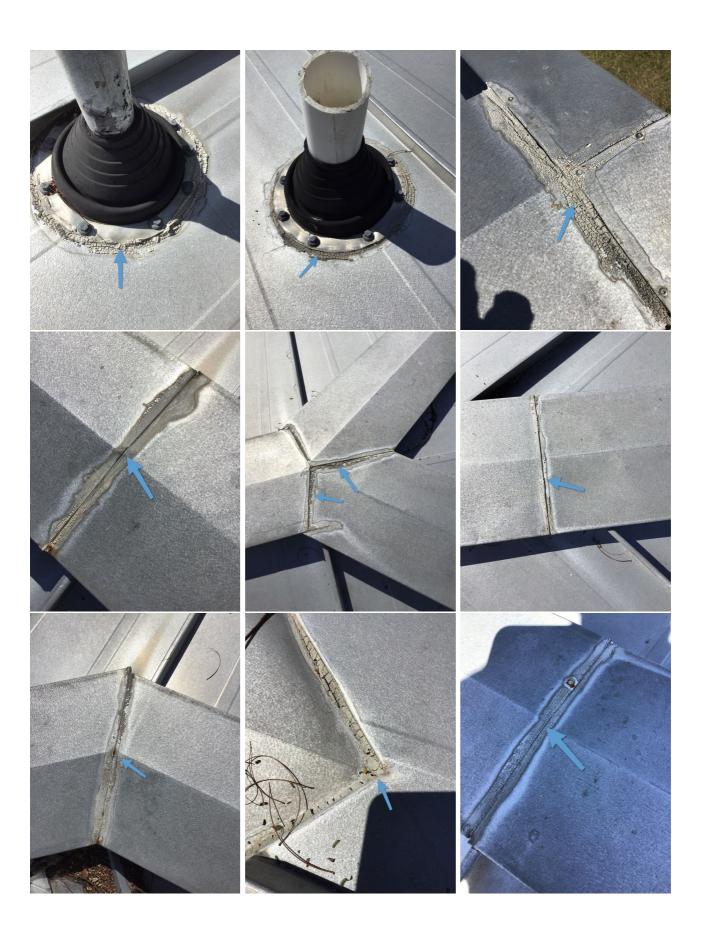
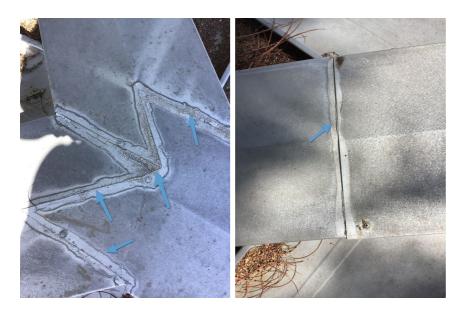
4.1.1 General

CAULKING

Caulking around fixtures (chimney, skylights, vents, siding, etc) of the roof are missing and/or deteriorated. Recommend qualified professional clean the surface and reapply caulking to effected areas.

Contact a qualified professional.
