PRO ELEMENTS HOME INSPECTION RESIDENTIAL TEMPLATE

1234 Main St. Homestead Fl 33030

04/01/2021 9:00AM

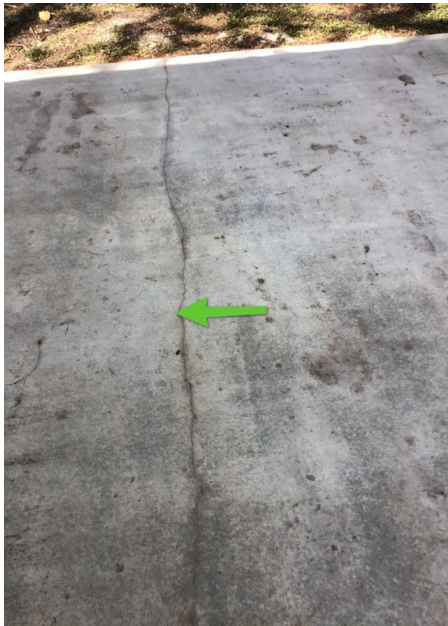
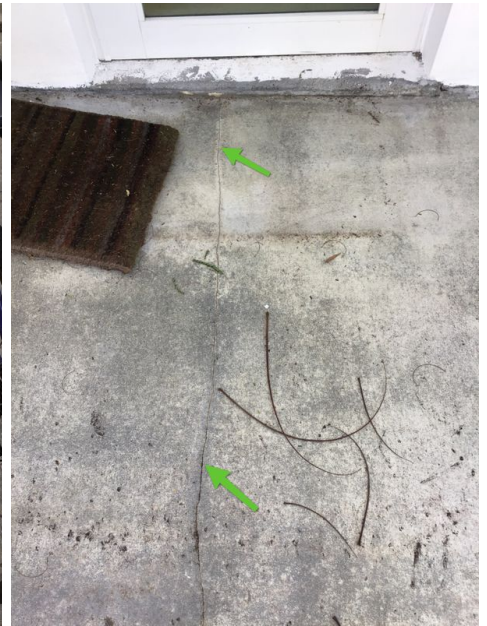
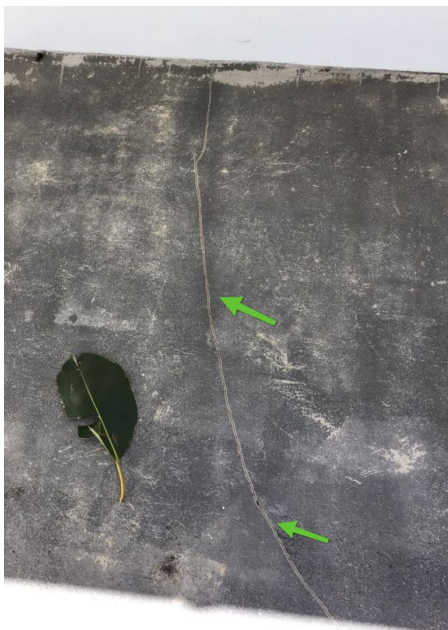
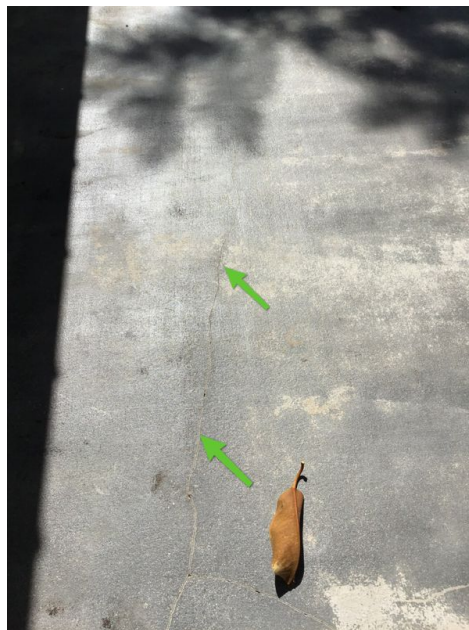
Exterior issues: Foundation

Foundation cracks have been found during the inspection. Recommend to monitor and make necessary repairs.

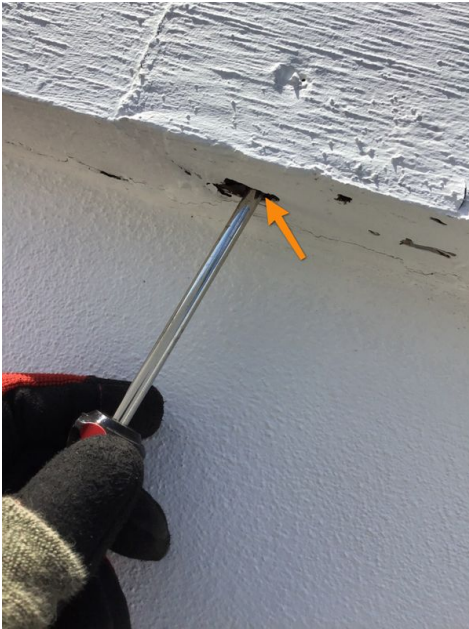
2.6.1 Soffit and Fascia

FASCIA ROT

Fungal rot was found at one or more sections *fascia* . Conducive conditions for rot should be corrected (e.g. leaking gutter, poor drainage). Recommend that a qualified contractor repair as necessary. All rotten wood should be replaced.

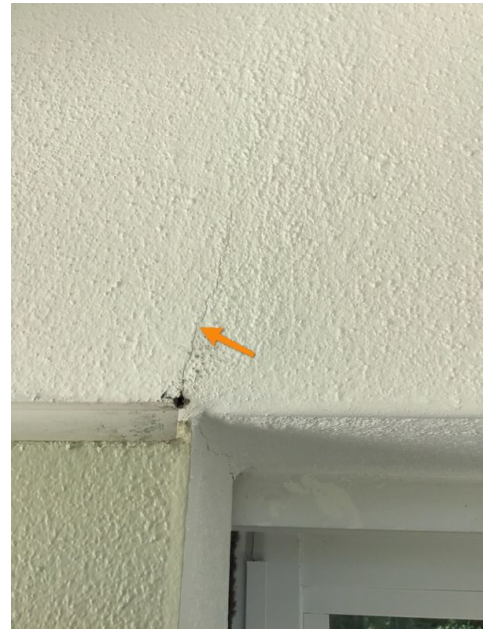
2.7.1 Stucco Walls

HAIRLINE STUCCO CRACKING

One or more minor hairline cracks were found in the stucco or wall areas. It is unknown the age of these cracks. At the time of inspection nothing out of the ordinary of normalized cracking was noticed. Recommend caulking and painting these areas, along with monitoring for future movement/widening. Stucco cracks over framing can allow moisture penetration behind wall areas and can potentially damage sheathing/framing. Note that areas concealed behind walls are not able to be evaluated without invasive testing and cannot be evaluated.

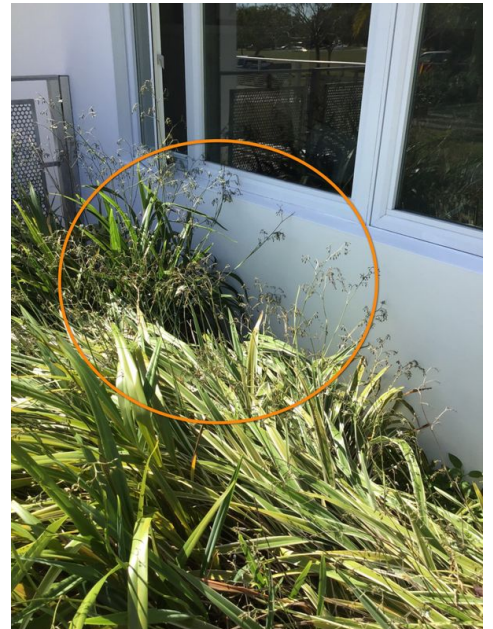
2.8.1 Vegetation and Grading

VEGETATION

Vegetation such as trees, shrubs and/or vines was in contact with or close to the building exterior. Vegetation can serve as a pathway for wood-destroying insects and can retain moisture against the exterior after it rains. This is a conducive condition for wood-destroying organisms. Recommend pruning, moving or removing vegetation as necessary to maintain at least 6 inches of space between it and the building exterior. A 1-foot clearance is better.

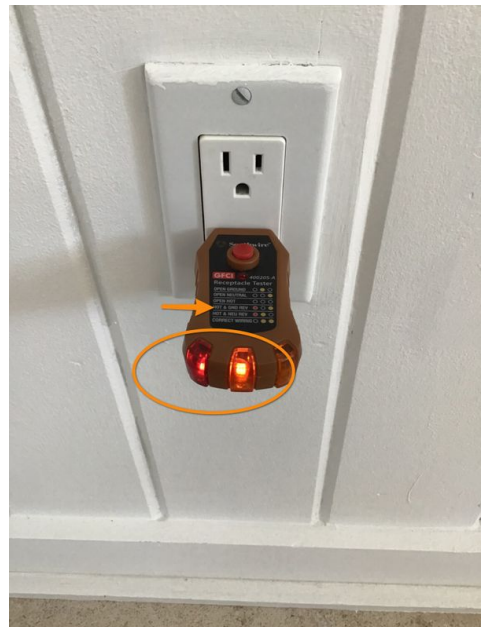
8.2.1 Electrical

HOT-NEUTRAL REVERSE

One or more electric receptacles had reverse-polarity wiring, where the hot and neutral wires were reversed. This is a shock hazard. Recommend that a qualified electrician repair as necessary.

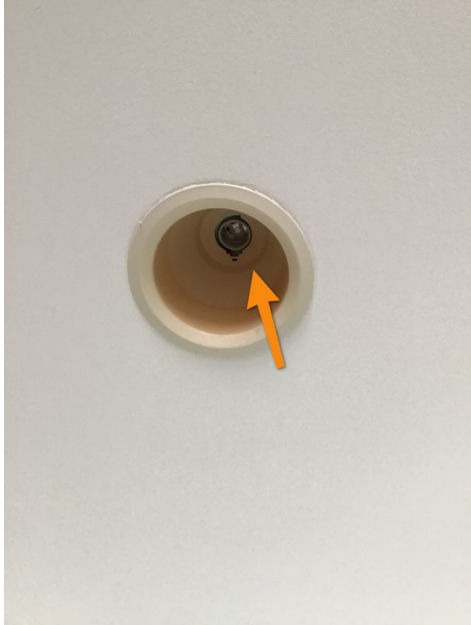
8.2.2 Electrical

LIGHT FIXTURE-NO BULB

One or more light fixtures have missing bulbs and could not be fully evaluated. Bulbs may simply need to be installed, or repairs or replacement may be necessary.

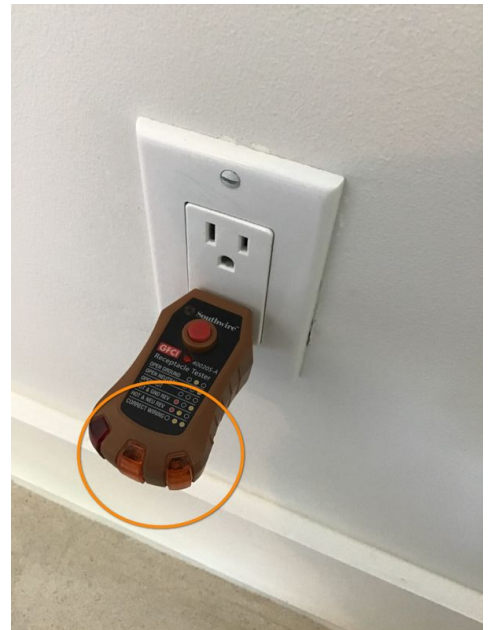
NO POWER

One or more electric receptacles appeared to have no power. Recommend asking the property owner about this. Switches may need to be operated or GFCI/AFCI protection may need to be reset to make some receptacles energized. If necessary, recommend that a qualified electrician evaluate and repair.

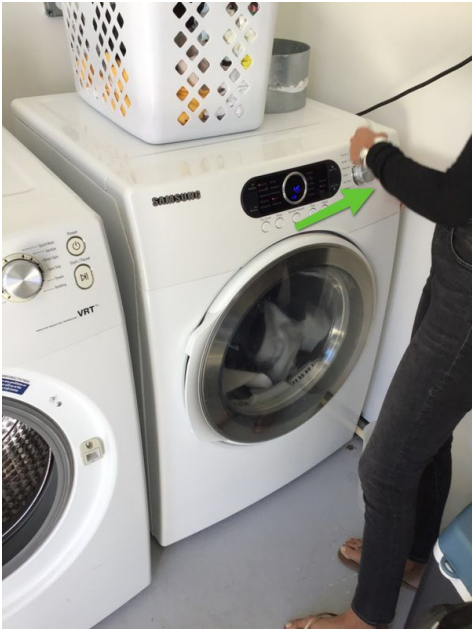
NOT INSPECTED

Dryer couldn't be inspected while running. Homeowner tried to starting the dryer but wouldn't start. Recommend monitoring.
